## CRITERION 3.0

### Conservation of Soil and Water Resources

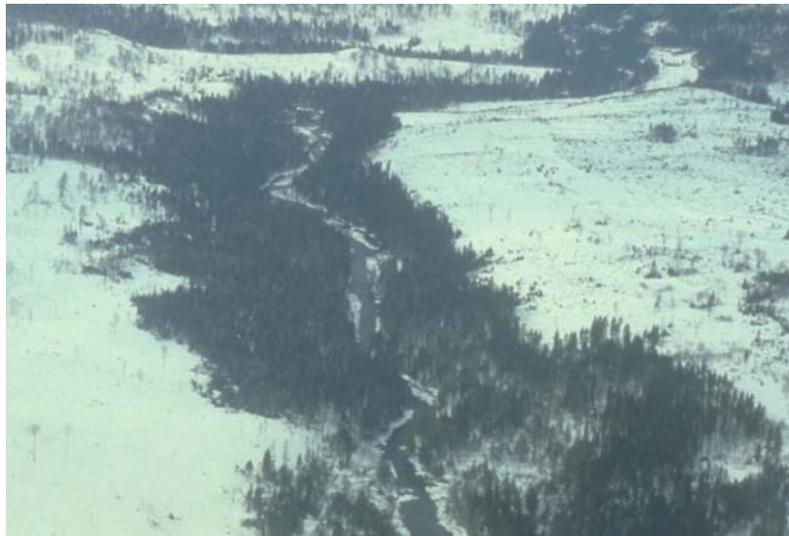
Figure 31. Forested riparian zone.

Generally the nature of the forested buffers ranges from mature timber in the headwaters to alder/shrub in the mid-stretches, to a mixture at the confluence.

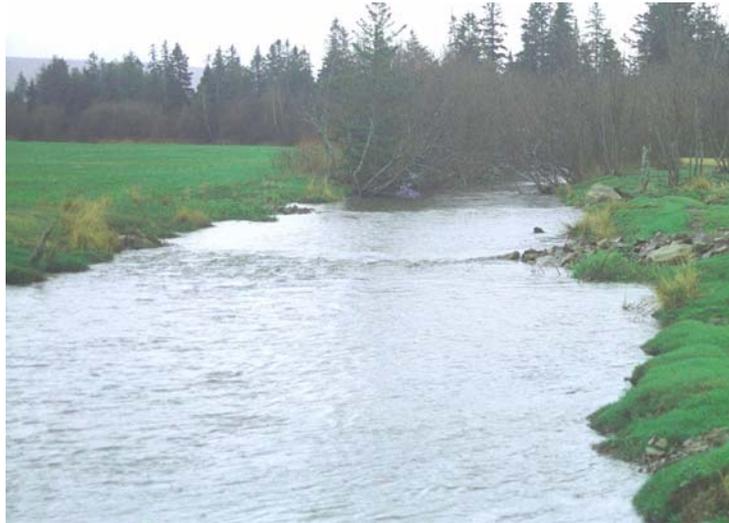
Figure 32. Bare riparian status.

The majority of non-forested buffers exist in agricultural areas among the higher order or larger streams. In the non-forested buffer environment, categories of bare, fringe and adequate were assigned (Figures 32-34). On highest and lowest stream orders in a non-forest condition, bare was the most common status of the buffer. Fringe status was more evident on the larger streams, while the areas where adequate vegetation grew tended to be along the smaller streams. Agriculture was the cause of highest incidence of infringement of all non-forest buffer conditions. This is reconfirmed by the adjacent land use patterns of agriculture, which is evident along bare, fringe, and adequate stream buffers.

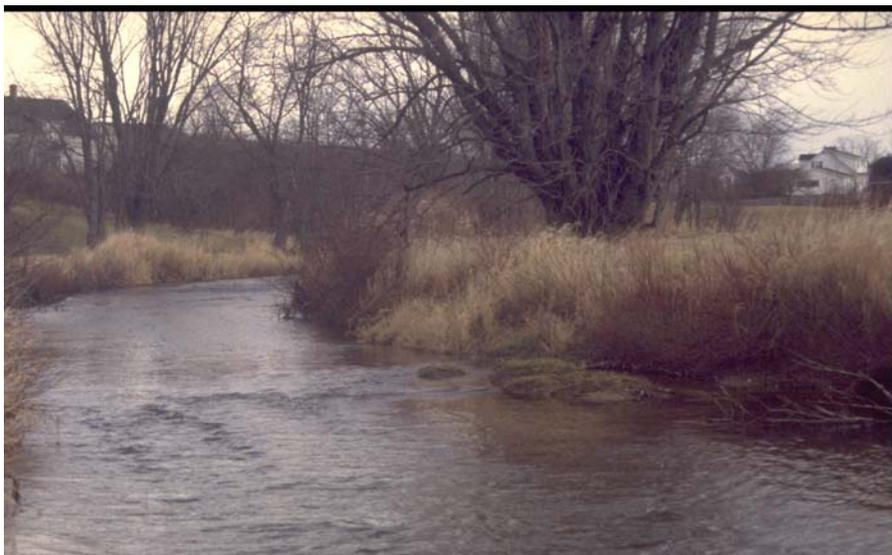
Figure 33. Fringe riparian status.

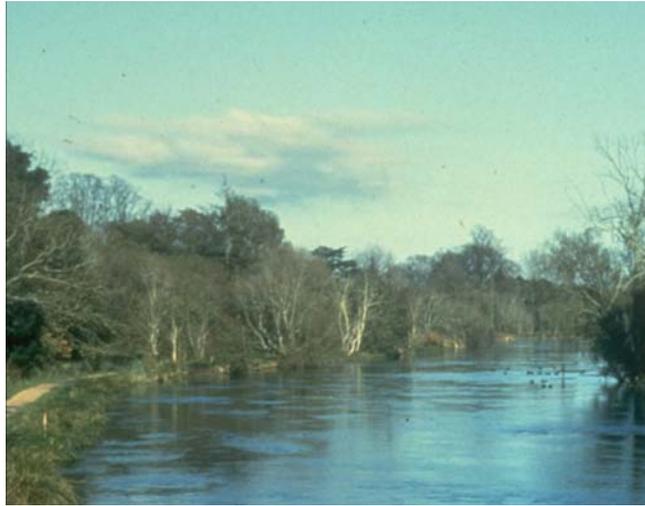
Figure 34. Adequate riparian status.
